Manhole Inspection Summary

Manhole # S21A__039MH

Location Address: **701 MOUNT ST**

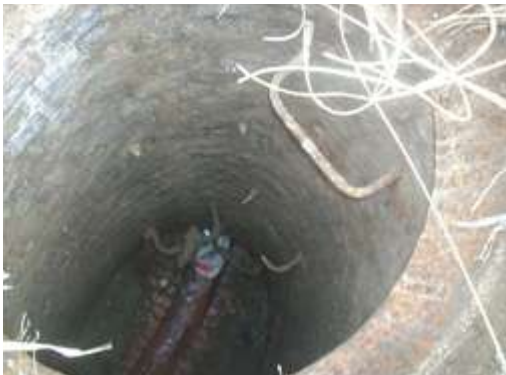
Defect 4

Steps Count: **2** Missing: **4** ☒ **Corroded**

MISSING AND CORRODED STEPS

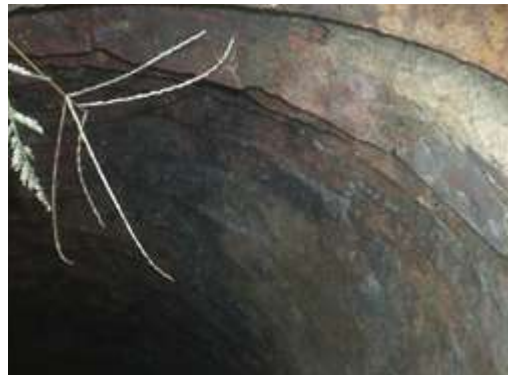
Defect 3

Condition: ☐ Sound ☒ **Cracked** ☐ Root Intrusion ☐ Loose Brick ☐ Deteriorated

Infiltration: ☐ None ☐ Joint ☐ Cracks ☐ Mortar ☐ Roots ☒ **Wall**

INFILTRATION OF CHIMNEY

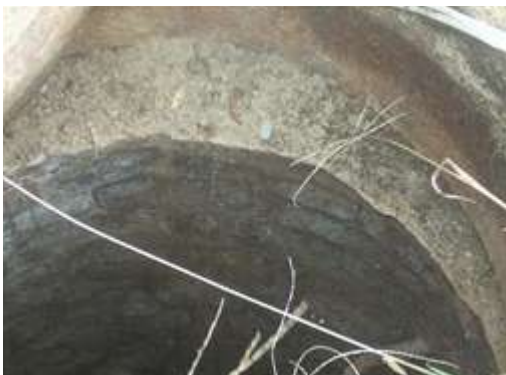
Defect 2

Frame Offset: **4** (in.) Condition: ☒ Sound ☐ Cracked ☐ Leaks

FRAME OFFSET and cracked frame

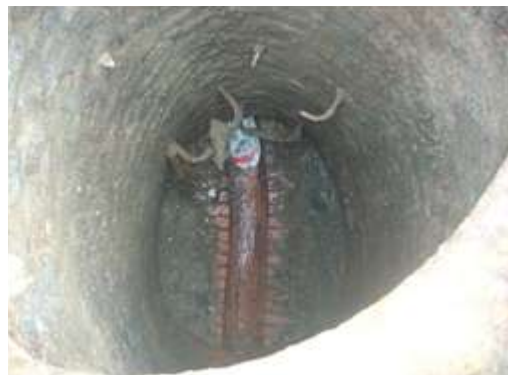
Defect 4

evidence surcharge

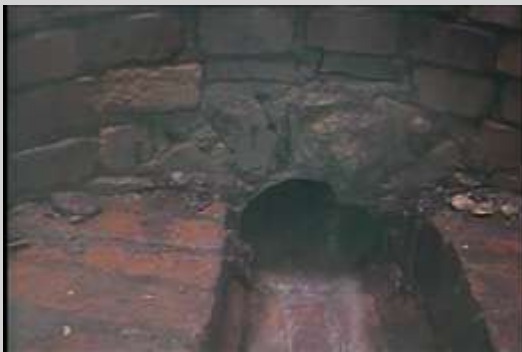
12 O'Clock Outflow

Pipe Height: **8.4** (in.) Rod and Bar (Angled)
Pipe Material: **Clay** ☐ Pipe Lined
Invert Depth: **9.11** (ft.) Flow Characteristics: **Slow**
Deposits: ☒ None ☐ Mud ☐ Sludge ☐ Debris ☐ Grease
Silt Depth: (in.) Deposits Extent:
Infiltration: **None** Pipe Seal Cond: **Sound**

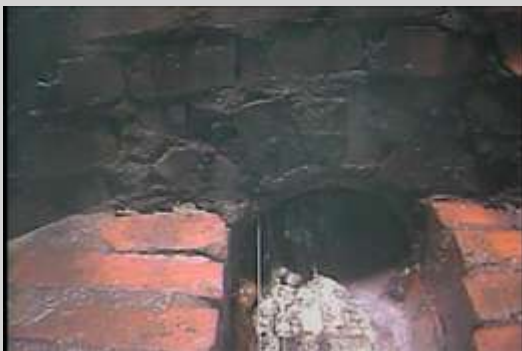
7 O'Clock Inflow

Pipe Height: **8.4** (in.) Rod and Bar (Angled)
Pipe Material: **Clay** ☐ Pipe Lined
Invert Depth: **9.00** (ft.) Flow Characteristics: **Slow**
Deposits: ☒ None ☐ Mud ☐ Sludge ☐ Debris ☐ Grease
Silt Depth: (in.) Deposits Extent:
Infiltration: **None** Pipe Seal Cond: **Sound**
